Interim Wastewater Pond Management Plan
US Magnesium LLC
Rowley, Utah

Submitted to: U.S. Environmental Protection Agency, Region 8

Prepared by: US Magnesium LLC

October 6, 2017

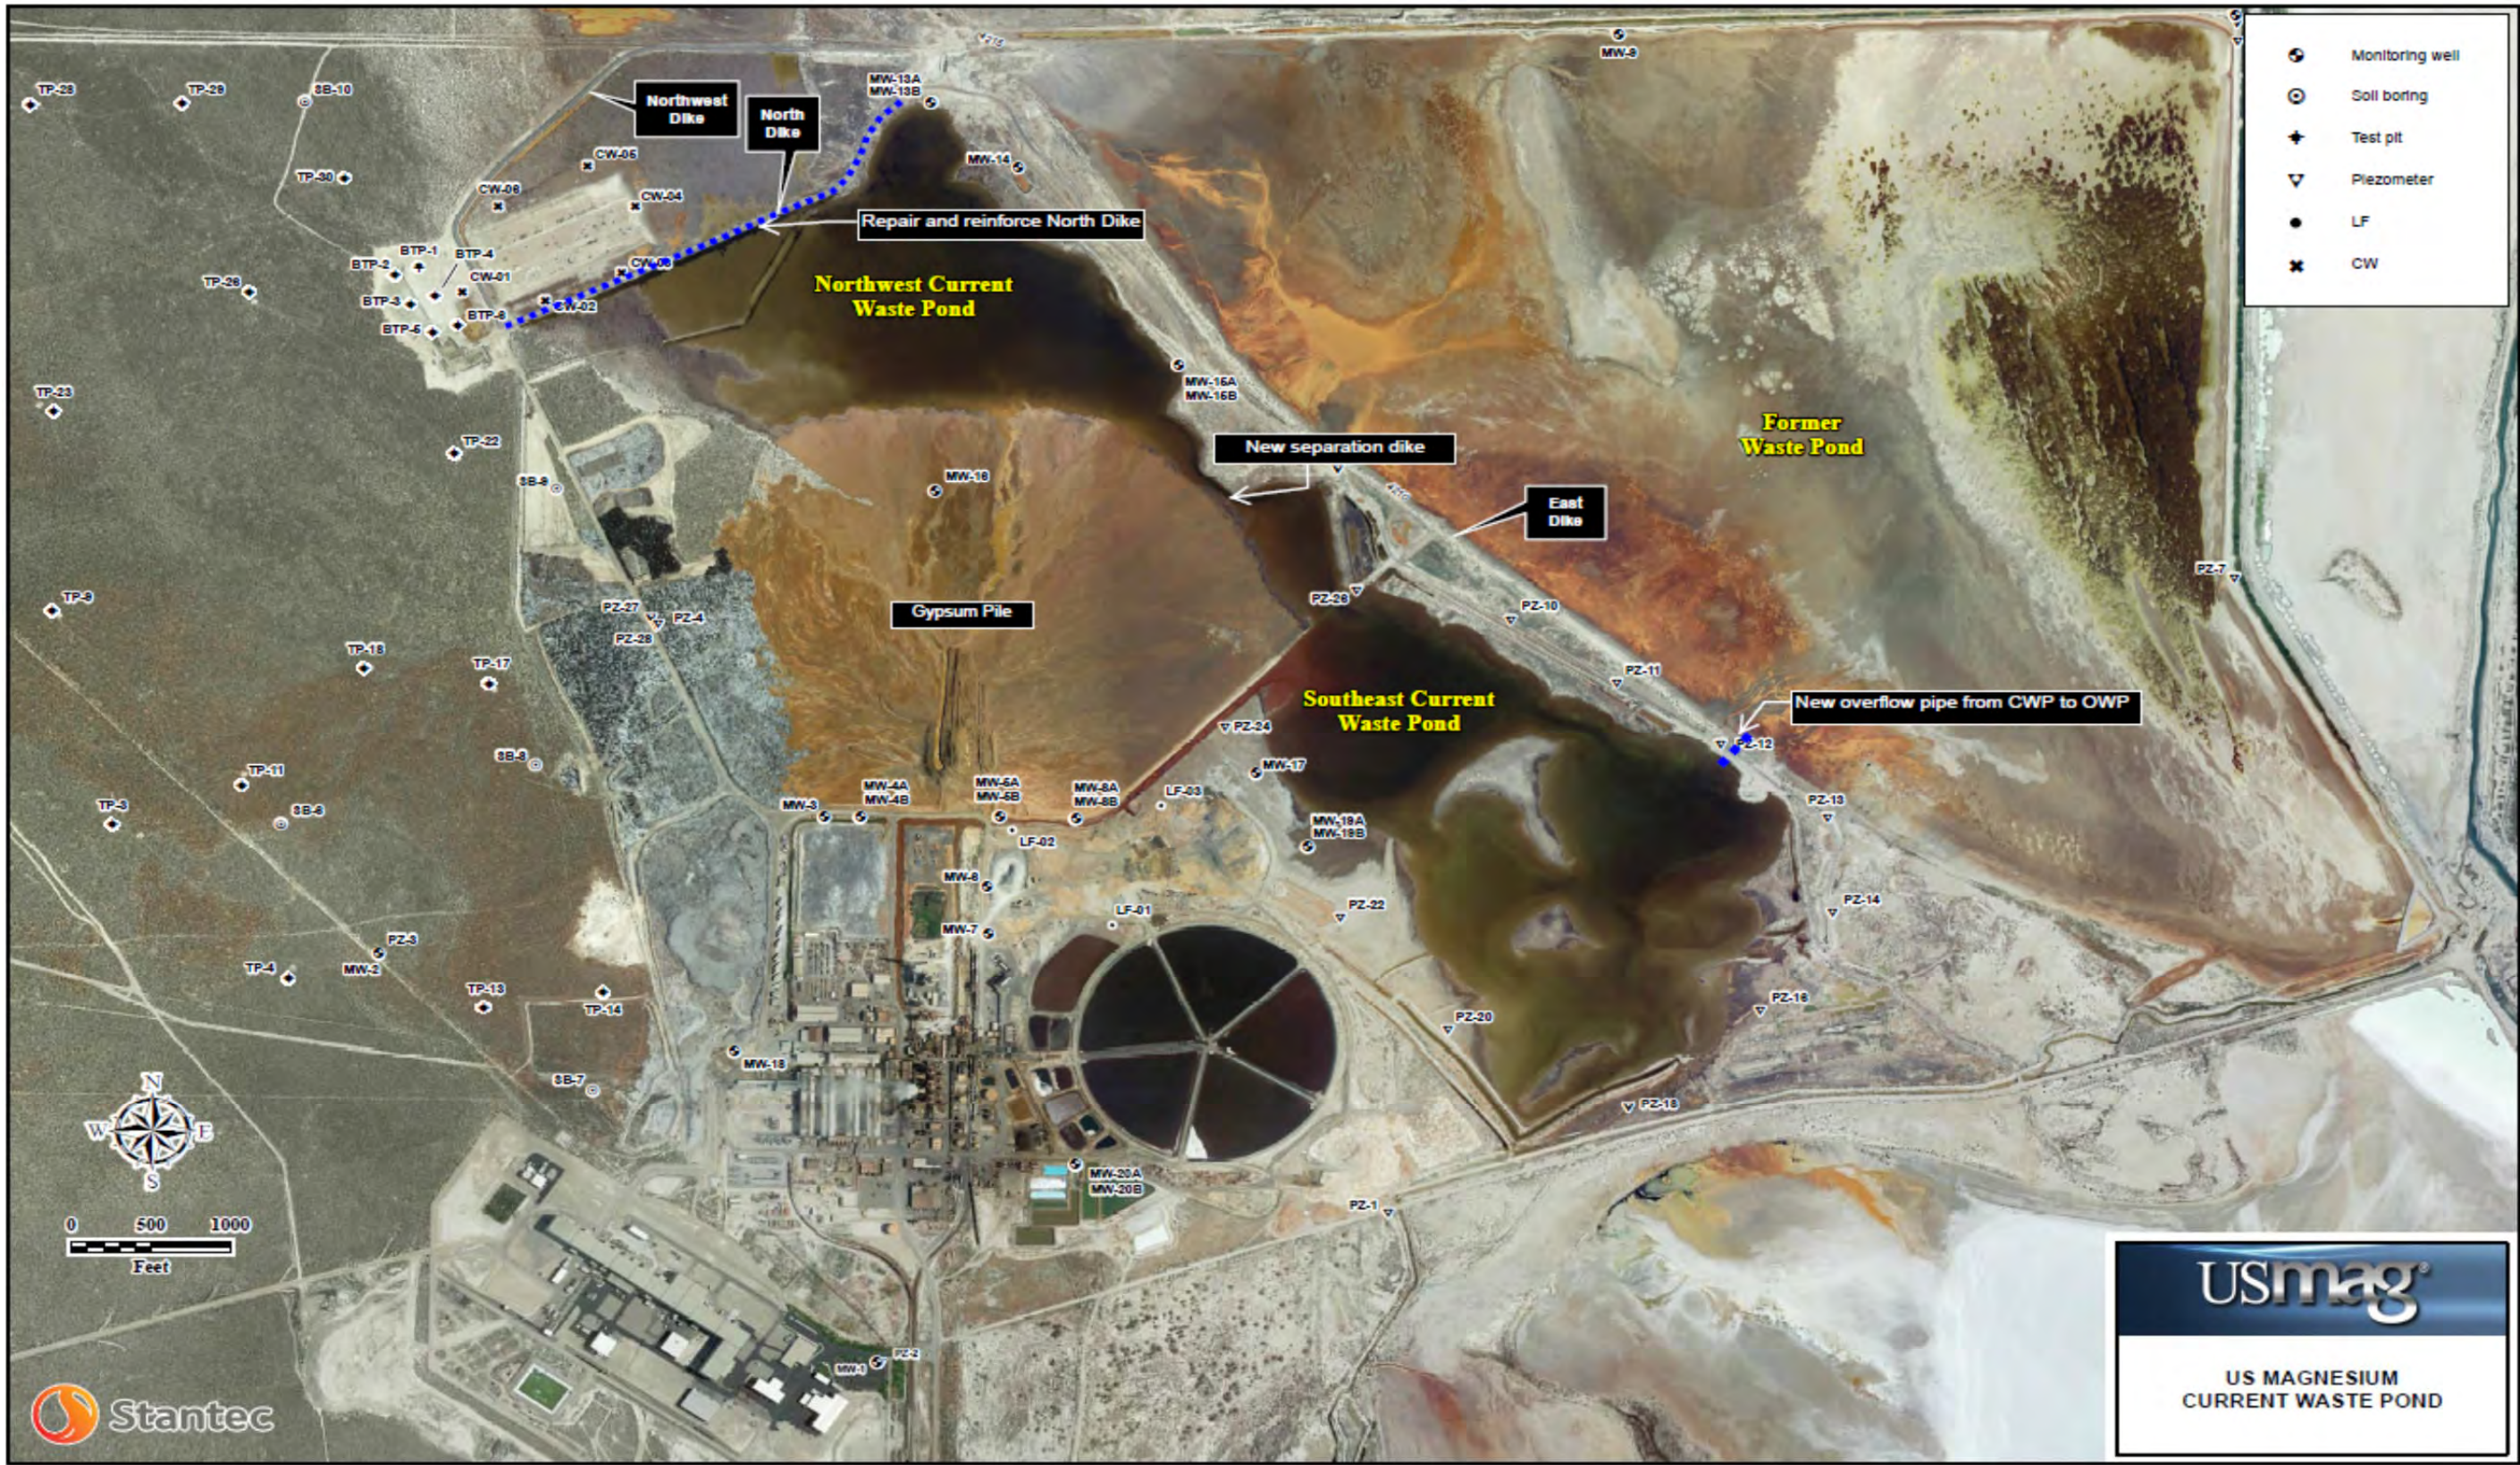
Figure 1. Features for Interim Management at the Current and Old Wastewater Pond

-
1. Repair and reinforce the north berm of the CWP;
 2. Install the DWQ-permitted overflow pipe from the CWP to the old waste pond; and
 3. Construct a new dike at the narrows between the northeast embankment of the CWP and the gypsum pile to separate the southeastern and northwestern portions of the CWP.

The locations of the above-described features are shown on Figure 1 that was provided to EPA to facilitate discussion during the August 29, 2017 conference call. During that call, USM also stated that the repairs to the north embankment had been completed, that there was no standing wastewater in the area between the north embankment and the northwest embankment, and that a small area of ponded water to the northwest of the northwest embankment (in the Angel Wing area) did not extend beyond the warning-signed fence. EPA requested that USM prepare a work plan describing the above-summarized measures and include photographs documenting the status of the CWP as described during the conference call. Photographs are contained in Appendix C.

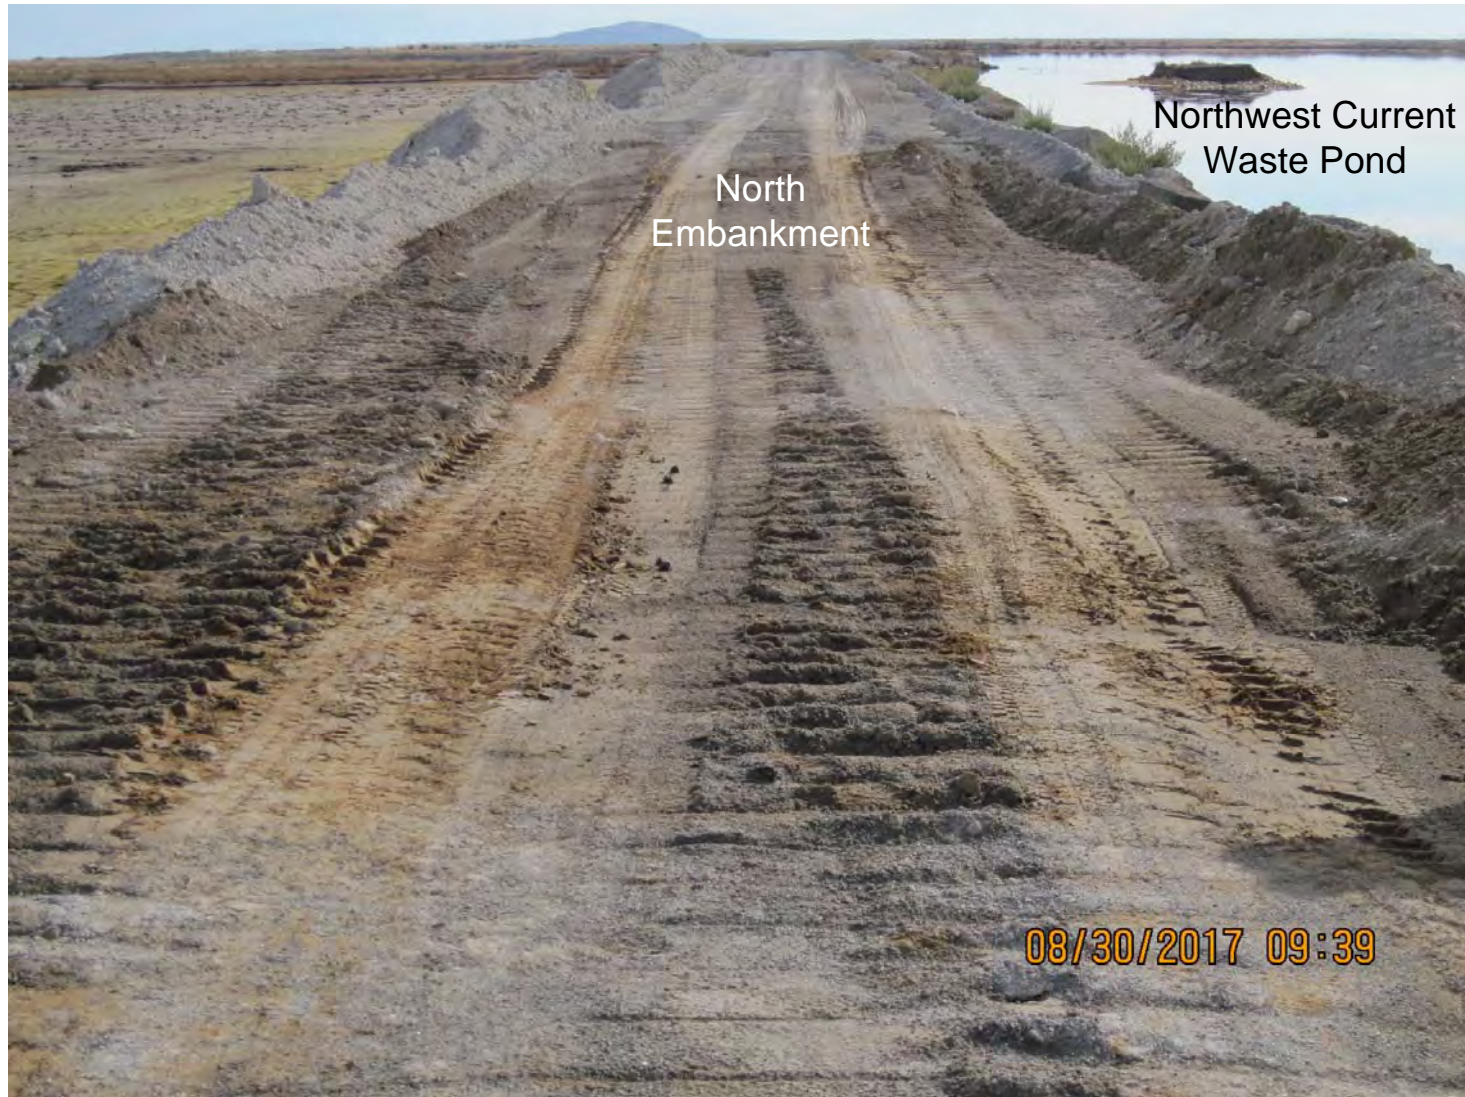
During the week of August 21, 2017, USM personnel repaired a breach in the north dike that had allowed wastewater to flow and fill the area between the north and northwest embankments during fall 2016. Photographs 1 and 3 (August 30, 2017) show the completed initial north dike repairs. Photographs 5 and 7 (August 30, 2017) show the lack of surface water in the area between the north and northwest embankments at the time of the initial north embankment repair.

Photo 1. North embankment, repaired and fortified area of former breach

During the weeks of September 11 and 25, 2017, USM personnel placed, dozed and compacted approximately 3,800 tons of silty-clay soil to fortify and widen the north embankment. Photographs 2 and 4 (September 28, 2017) show the widening of the north dike that included placement of soil to create a truck turnaround (Photograph 6) that significantly fortified the area of the former breach and will facilitate future maintenance. During the week of October 2, 2017, USM personnel completed reinforcement and widening of the north embankment, including construction of an additional truck turnaround near its east end.

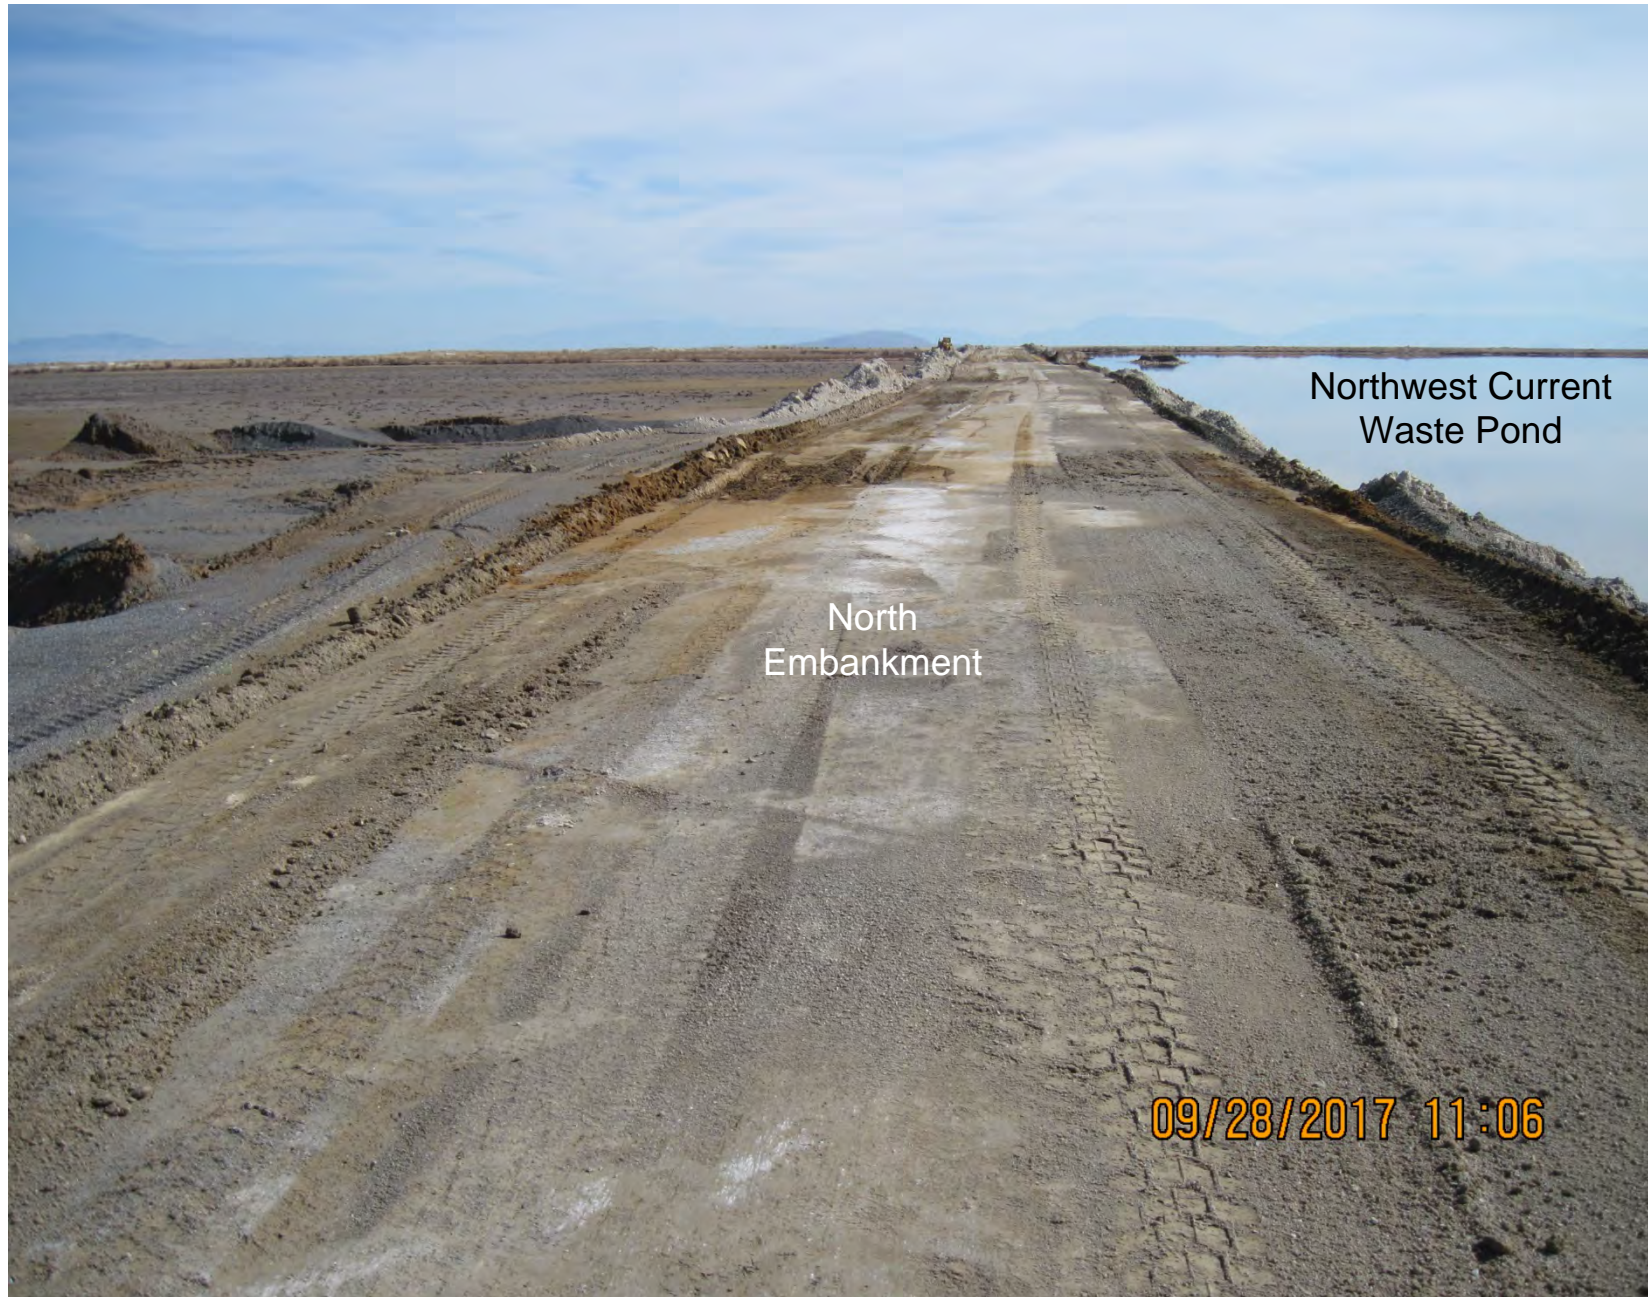
Photo 2. North embankment, repaired and fortified area of former breach and widening of north embankment

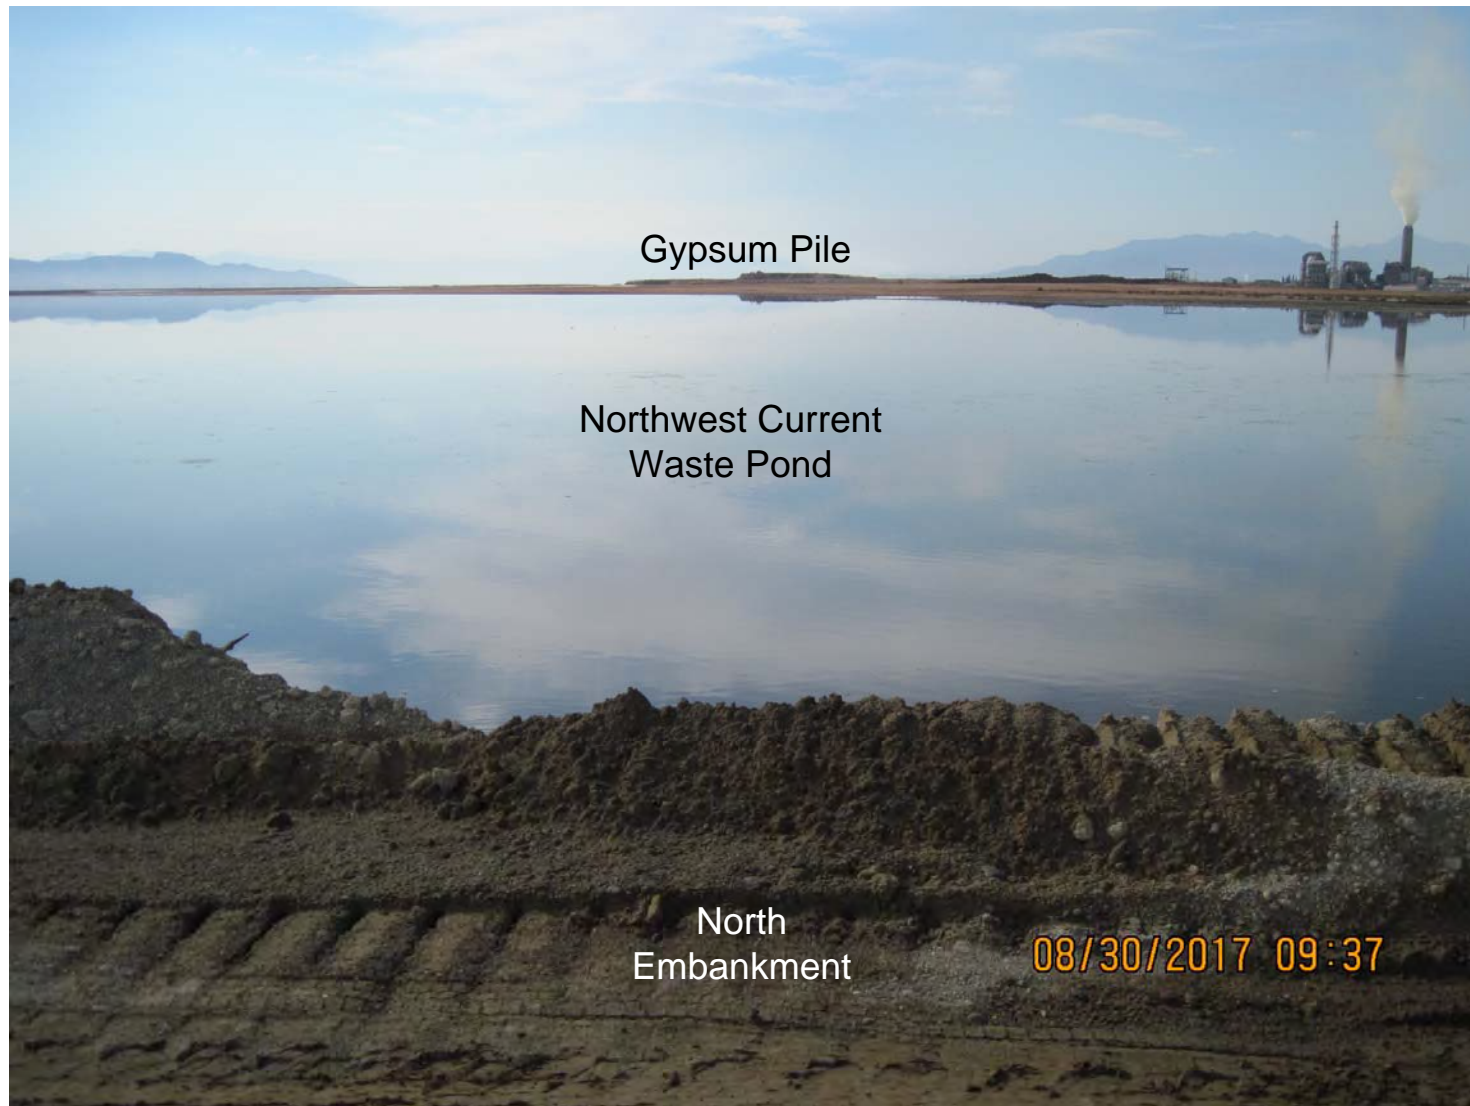
Photo 3. North embankment, view toward east

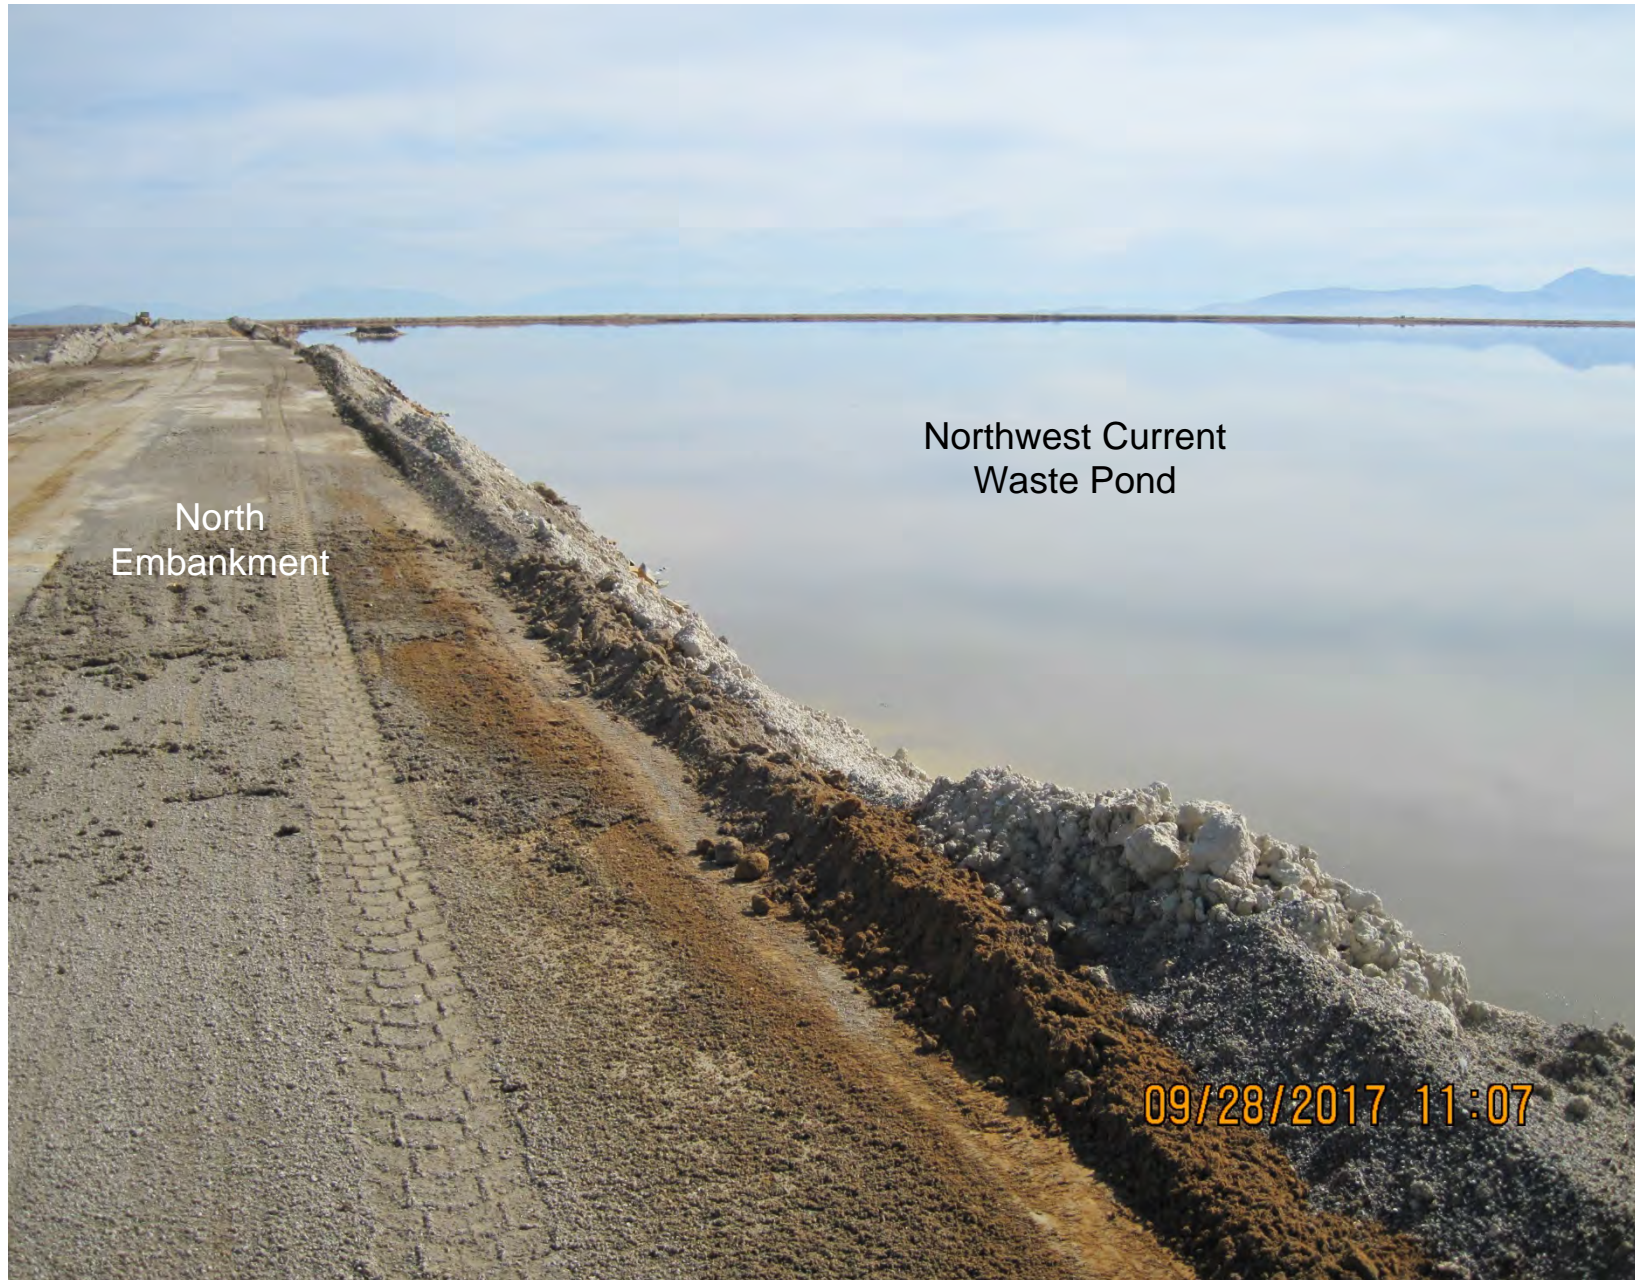
Photo 4. North embankment, view toward northeast

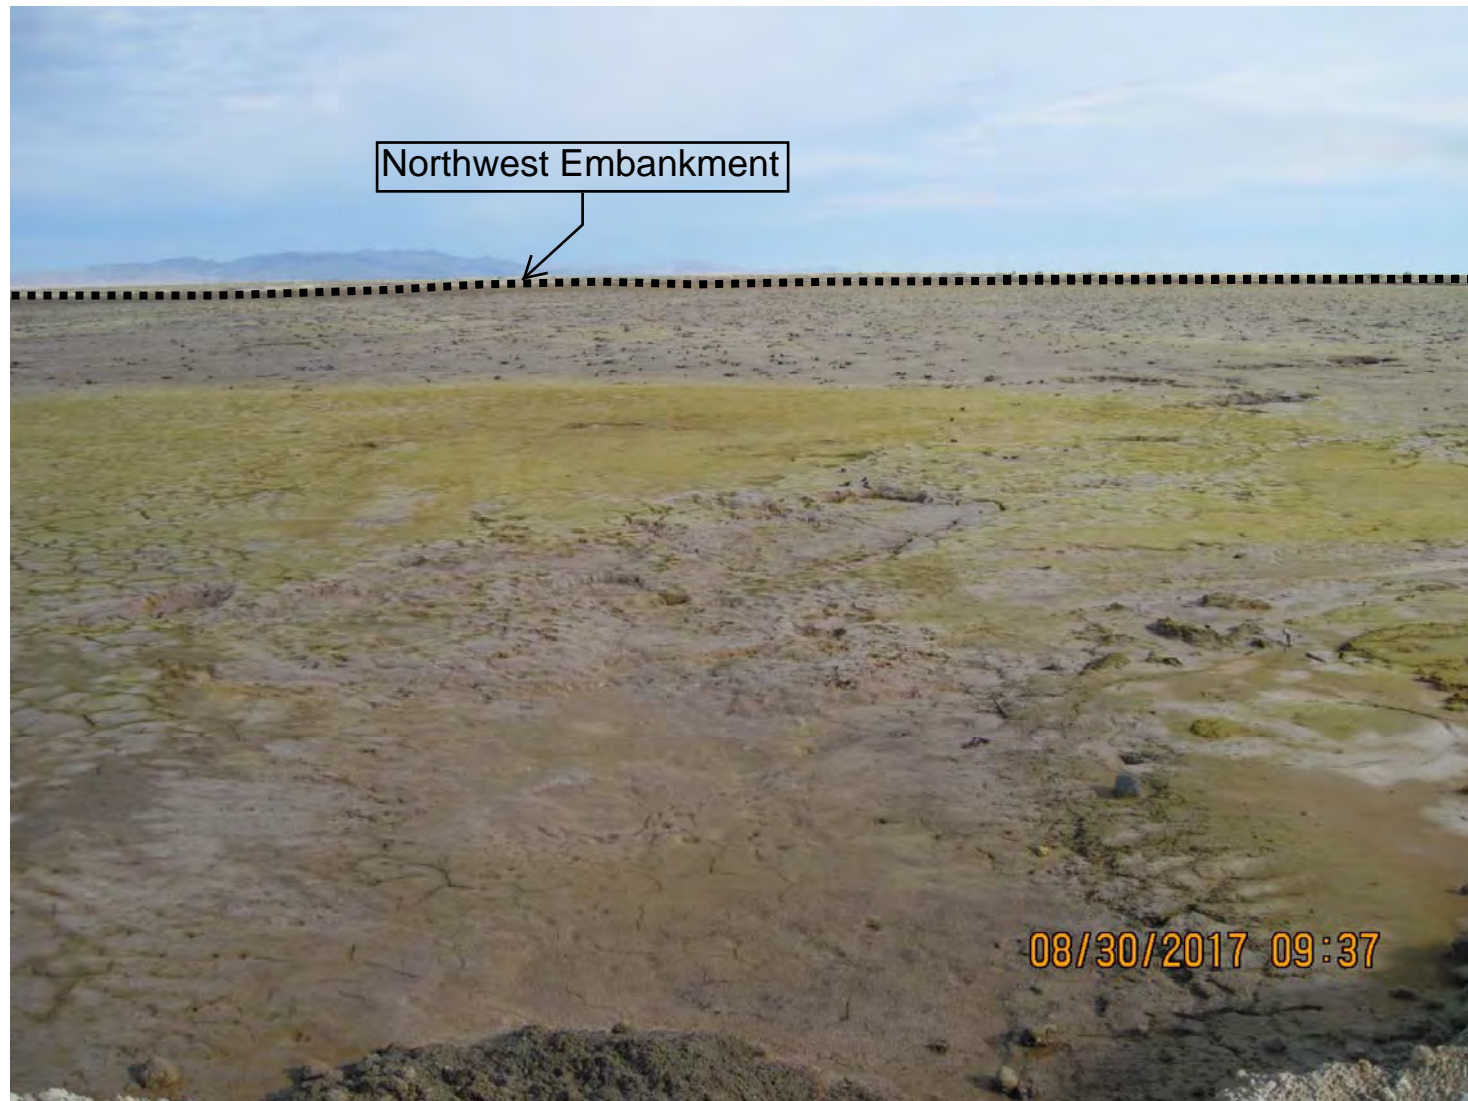
Photo 5. North embankment, view toward northwest

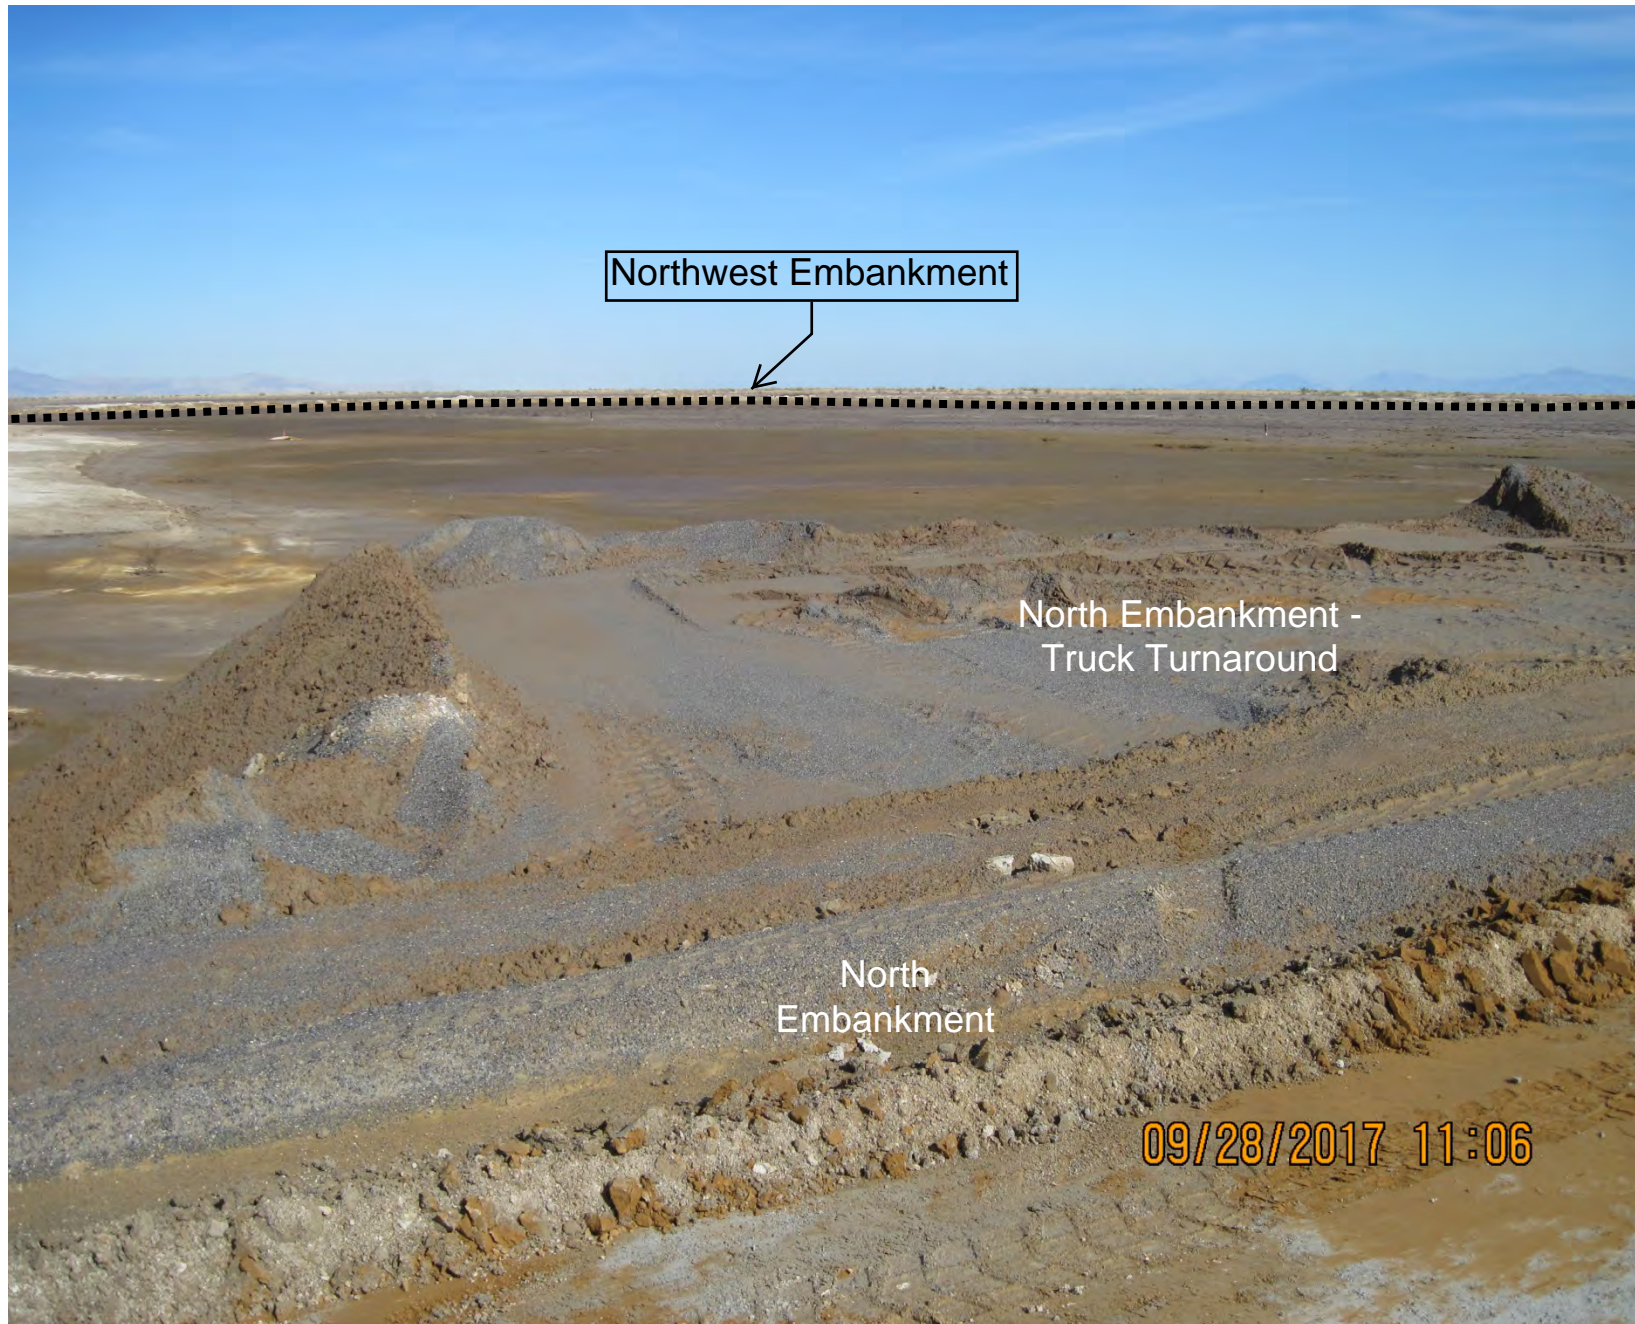
Photo 6. North embankment, view toward northwest

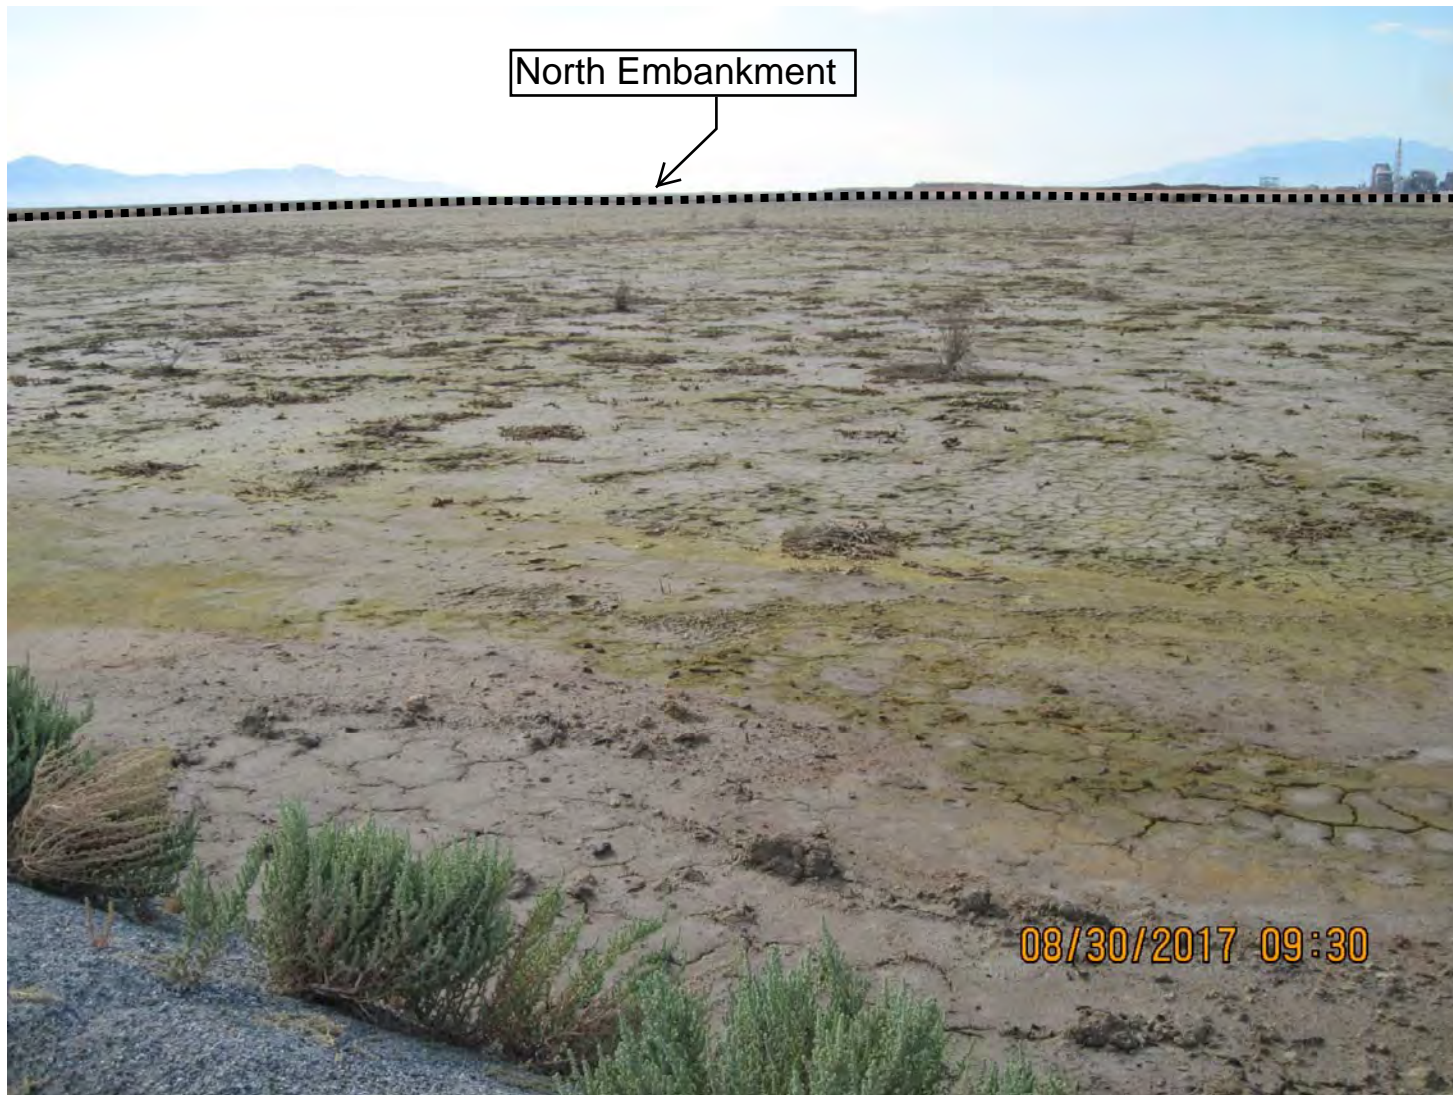
Photo 7. Northwest embankment, view toward east-southeast

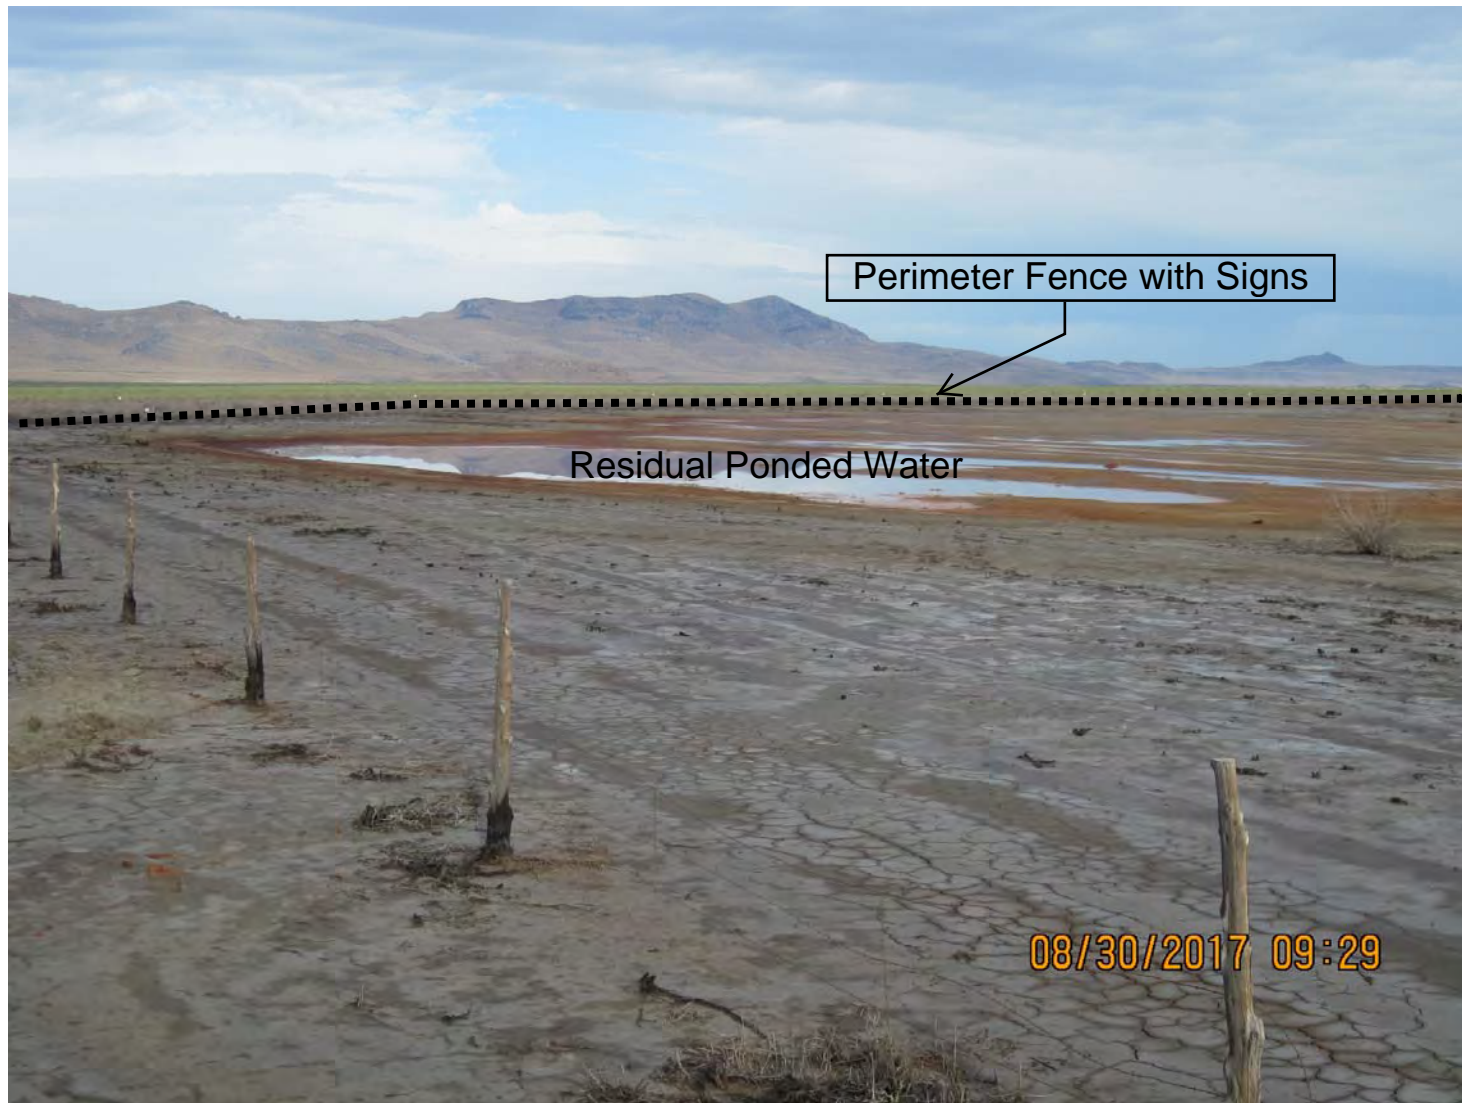
Photo 8. Northwest embankment, view northwest toward perimeter fence

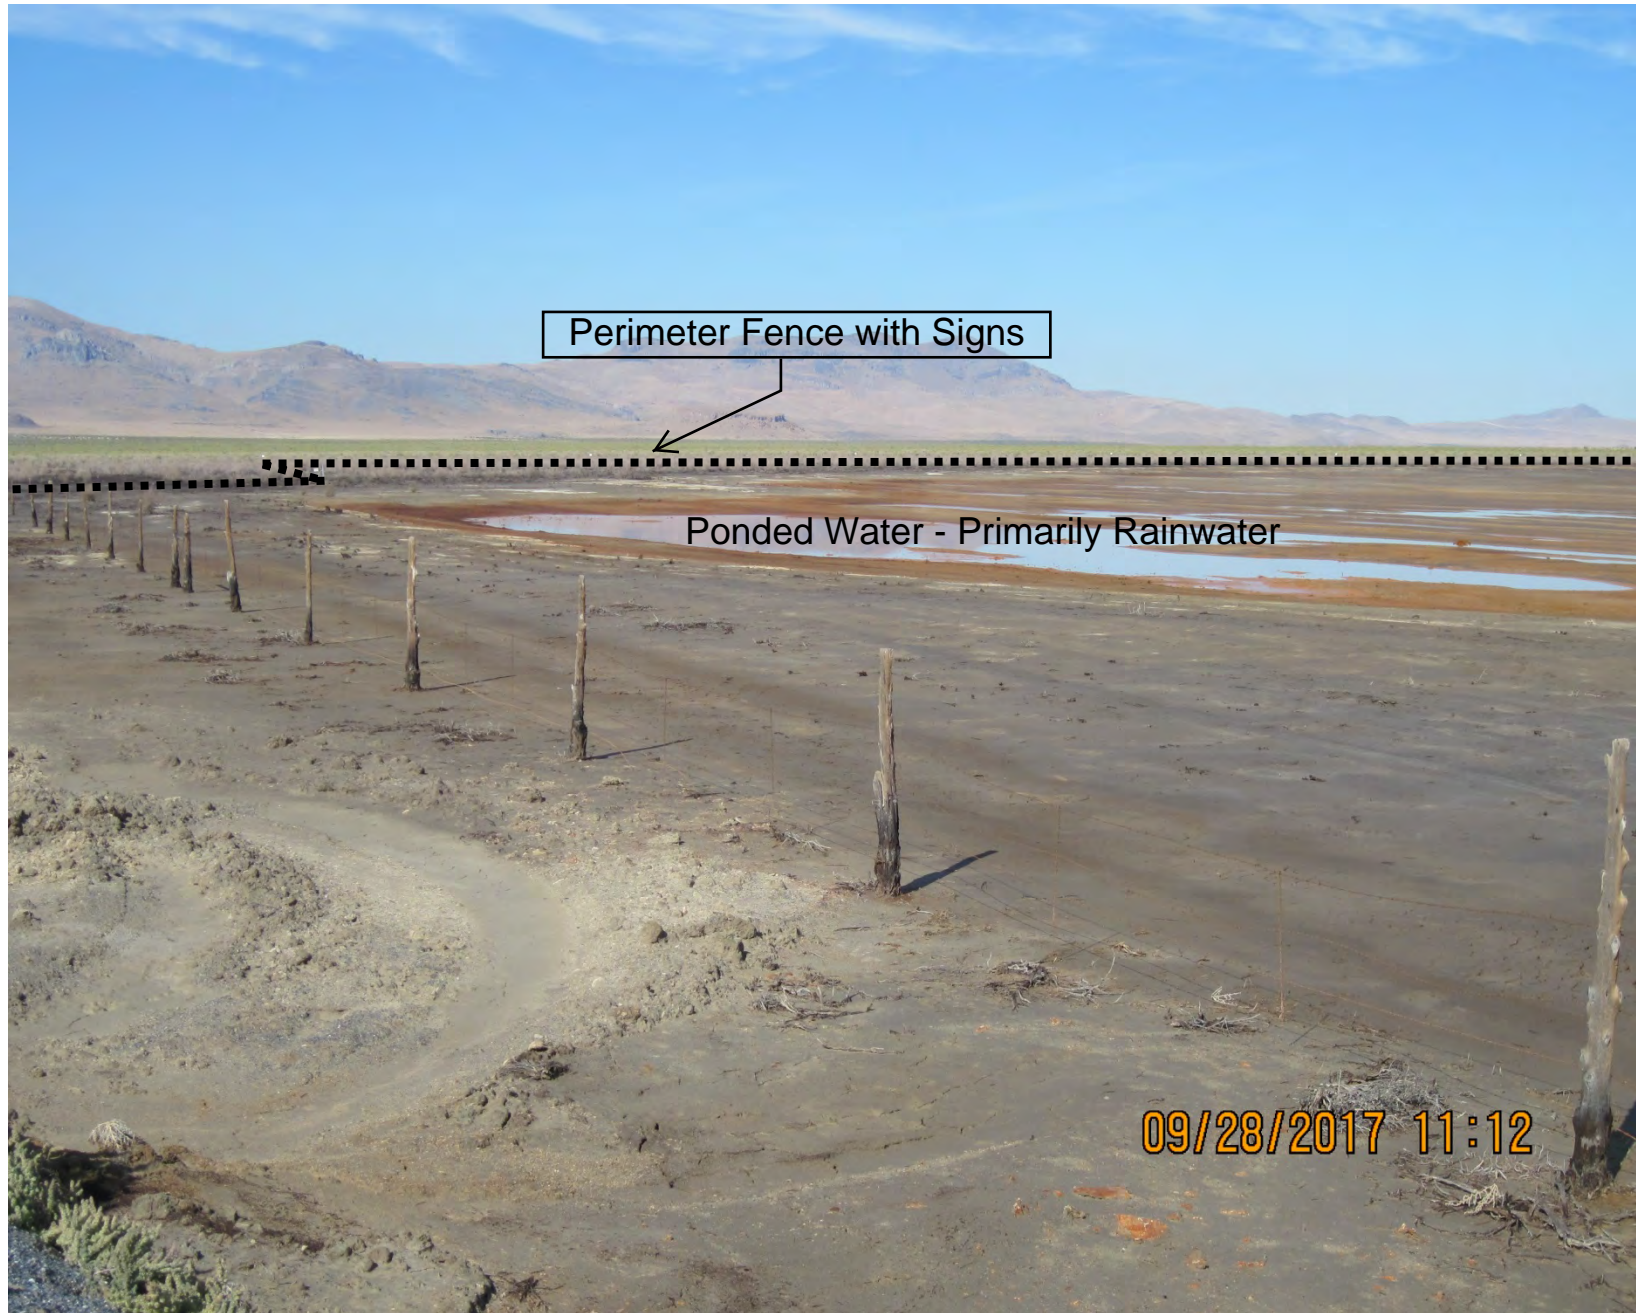
Photo 9. Northwest embankment, view northwest toward perimeter fence

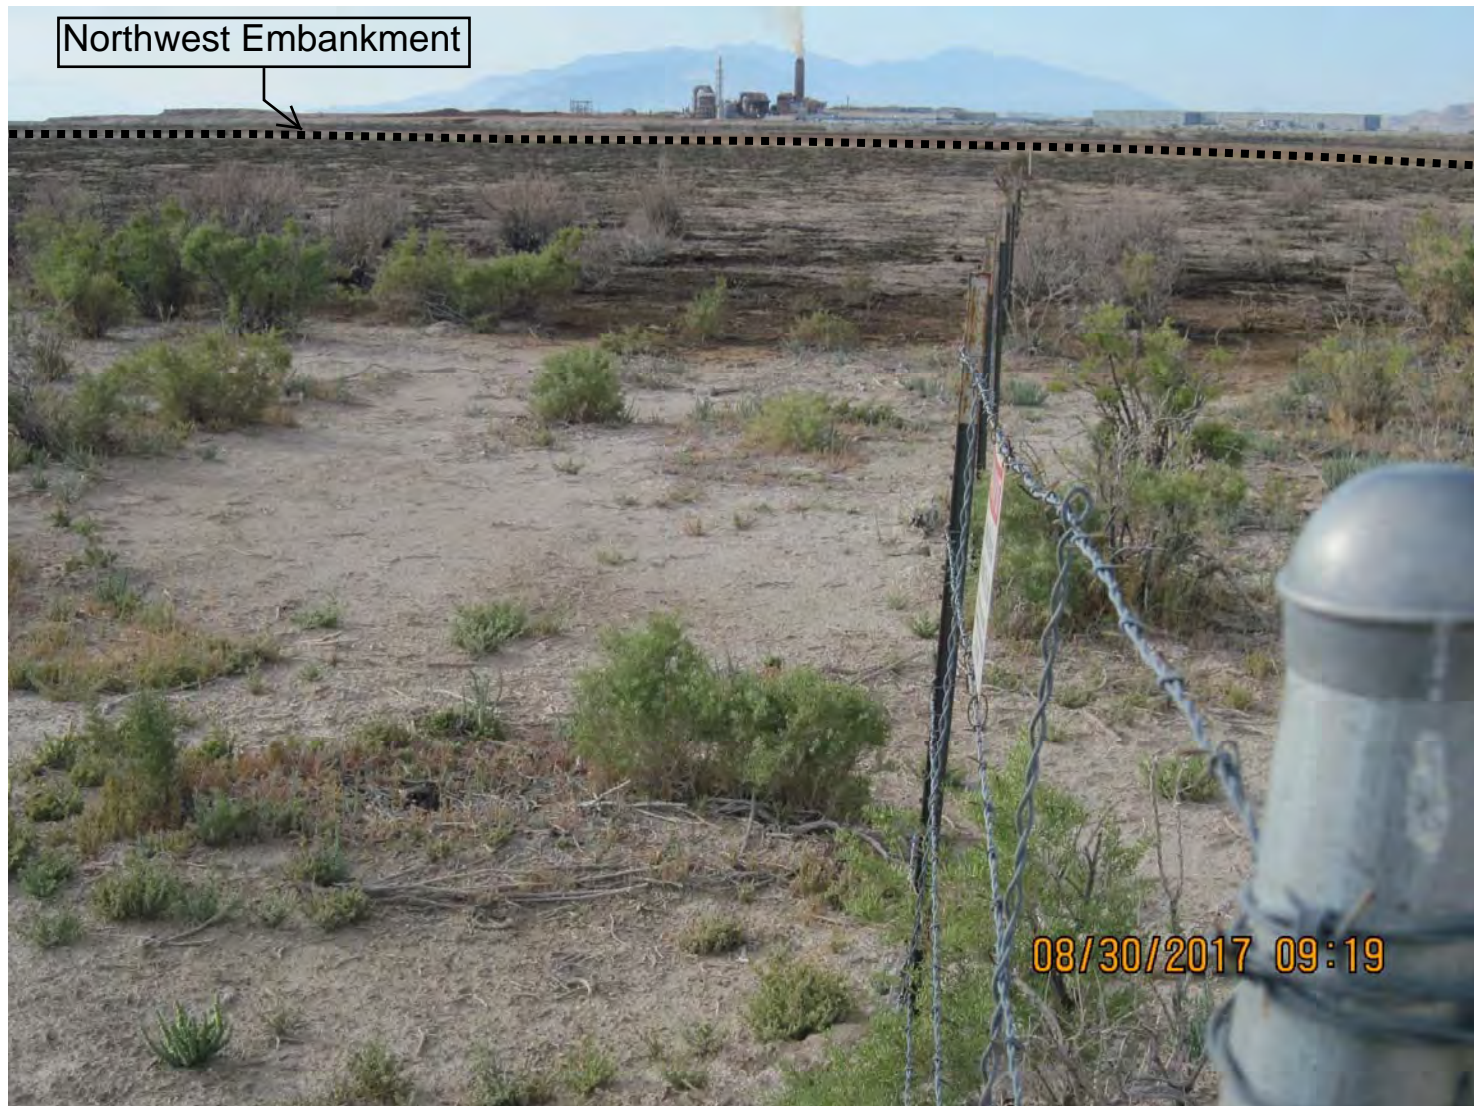
EPA's July 21, 2017 letter also states that "USM must assess the areal extent of the recent release and reconstruct the fence, with warning signs installed under the February 2014 EPA RCRA AOC, to ensure the public is not exposed to acidic water contaminated with chlorinated hydrocarbons." As shown on Photographs 8, 10 and 11 (August 30, 2017), a small pond of residual water remained in the area beyond the northwest embankment (in the Angel Wing area). The residual ponded water was entirely within the existing fenceline and the warning signs remain posted and legible. The warning signs are 9 inches by 12 inches and display "Warning - Keep Out - Hazardous Materials Area Beyond This Point." Photograph 9 (September 28, 2017) shows ponded water within the posted, fenced area, but the ponded water is likely primarily or entirely rainwater that accumulated in this low area. Over the weekend of September 23 and 24, 2017, USM recorded 1-inch of precipitation at the rain gauge located at the plant site. USM anticipates that the measures described in this PMP will prevent any future releases to the Angel Wing area; however, the existing fence and signs will be maintained as originally installed.

Photo 10. Northeast corner of perimeter fence, view toward south
